STORMWATER SOLUTIONS: CHANNEL LINING

GEO PRODUCTS, LLC | CONCRETE CANVAS®

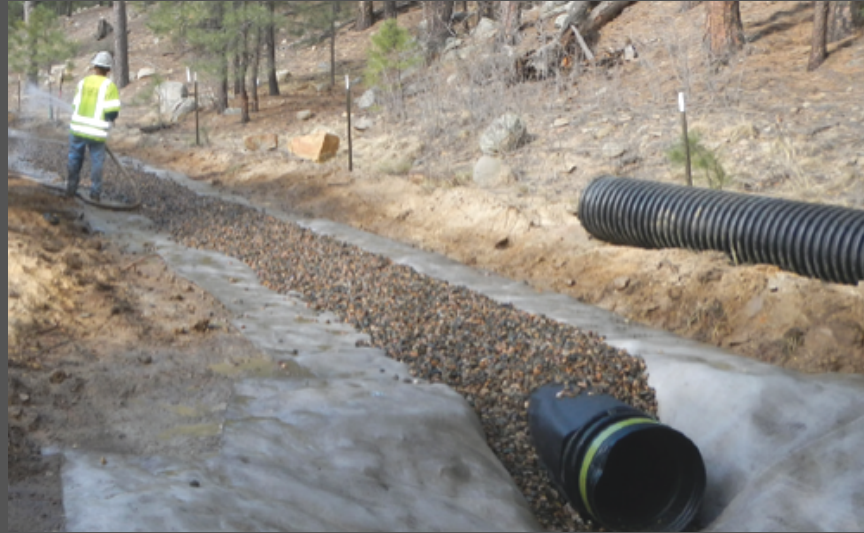
The completed drainage system
